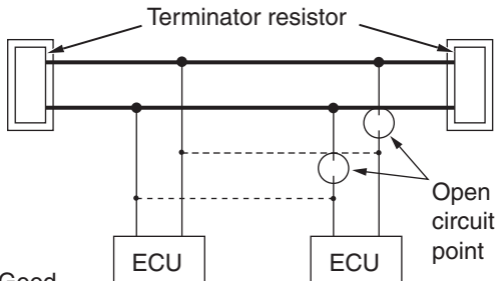
No good

— : Shows main bus line.

— : Shows sub bus line.

--- : Shows restored CAN bus line.
